NASA CR-72966
R-8494-2

ROTATING AND POSITIVE-DISPLACEMENT PUMPS
FOR
LOW-THRUST ROCKET ENGINES

FINAL REPORT
VOLUME II
FABRICATION AND TESTING

ROCKETDYNE DIVISION
ROCKWELL INTERNATIONAL
CANOGA PARK, CALIFORNIA

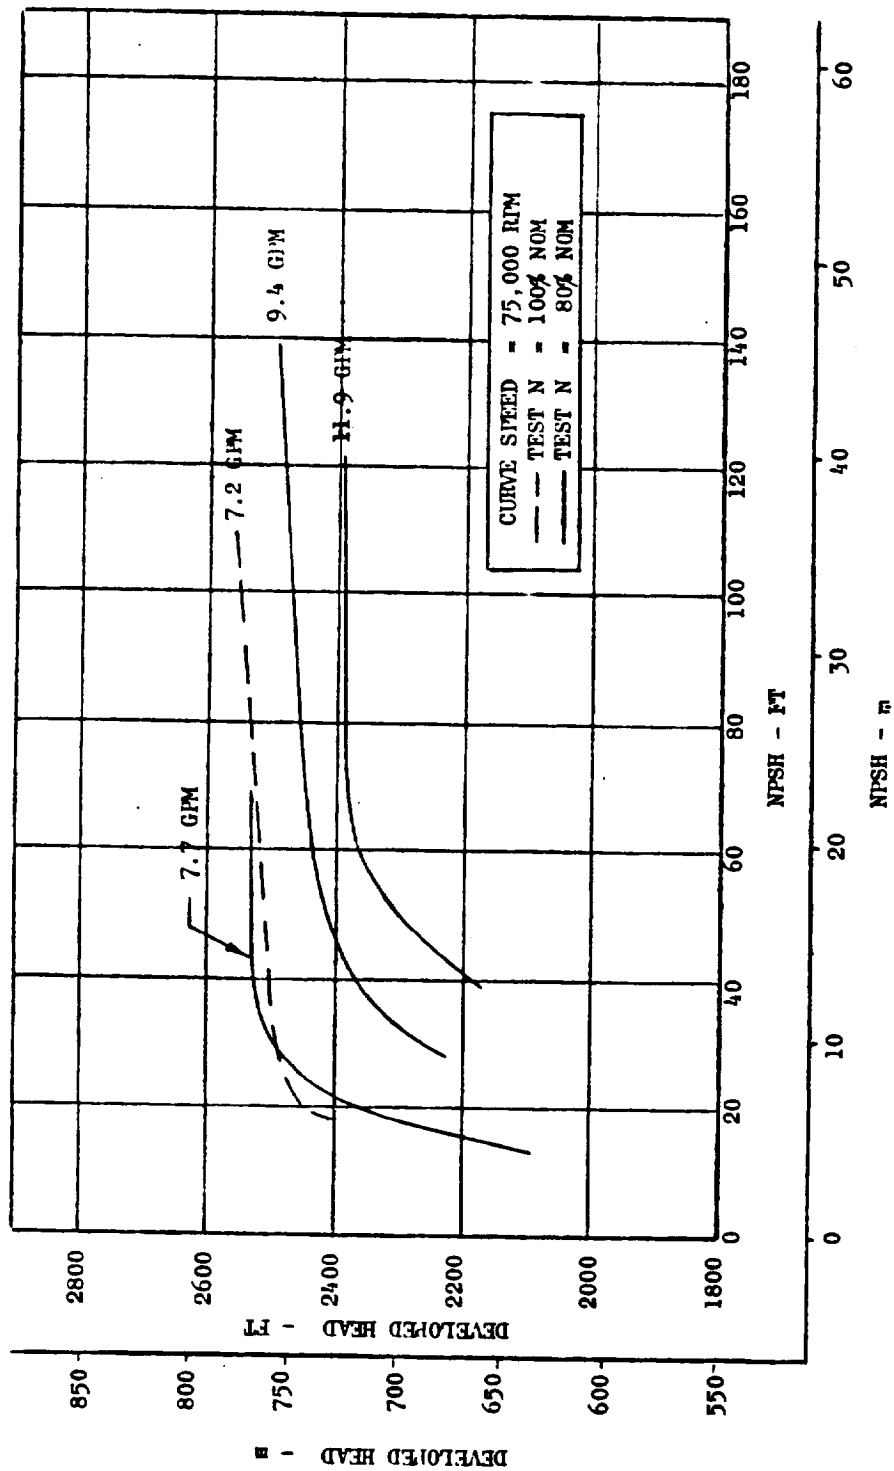
The suction performance data obtained with the inducer tip diametral clearance at .018 inch (2.8×10^{-4} m) and .011 inch (2.8×10^{-4} m) is presented in Fig. 27 and 28, respectively. In Fig. 29 the NPSH level at 2 percent and 4 percent head drop is plotted as a function of inducer flowrate for .011 inch (2.8×10^{-4} m) inducer clearance. The same figure also shows the NPSH requirement at 2 percent head drop with an inducer clearance of 0.018 inch (4.6×10^{-4} m) diametral clearance. It is noteworthy that little difference exists between the 2 percent and 4 percent criteria, and indication of a steep $\Delta H/\text{NPSH}$ characteristic in the critical zone. In examining Fig. 28 this is seen particularly true at low flowrates; as the flowrate increases there is a growing tendency to droop.

Figure 27. 12 gpm Rotating Pump Suction Performance in Freon 12
(Inducer Clear = 0.018 in. (4.4 x 10⁻⁴m) Diameter)

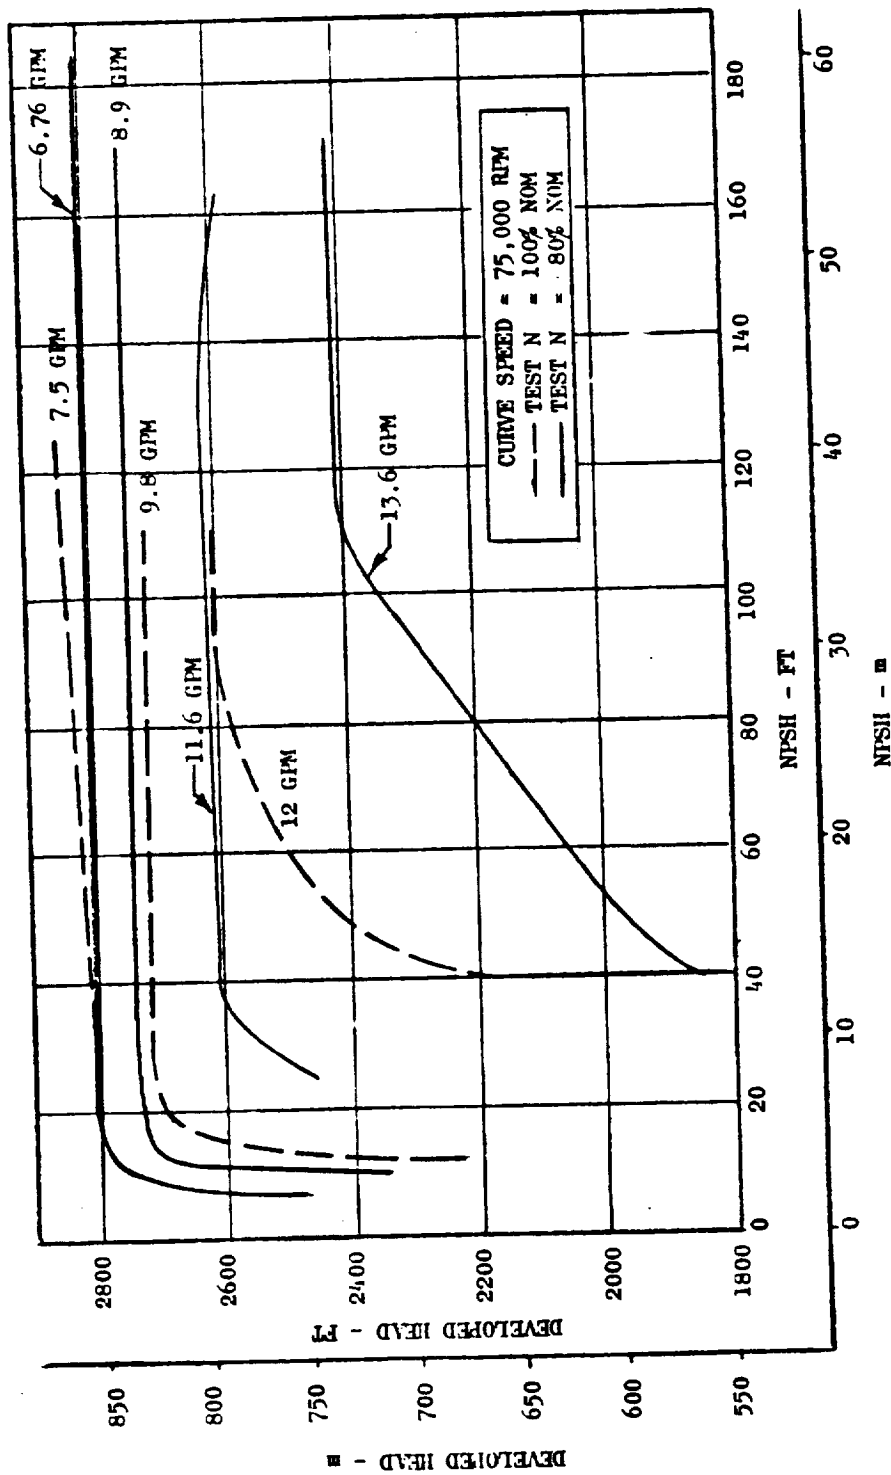
Figure 28. 12 gpm Rotating Pump Suction Performance in Freon 12
(Inducer Tip Clear = 0.011 in. (2.8×10^{-4} m) Diameter)

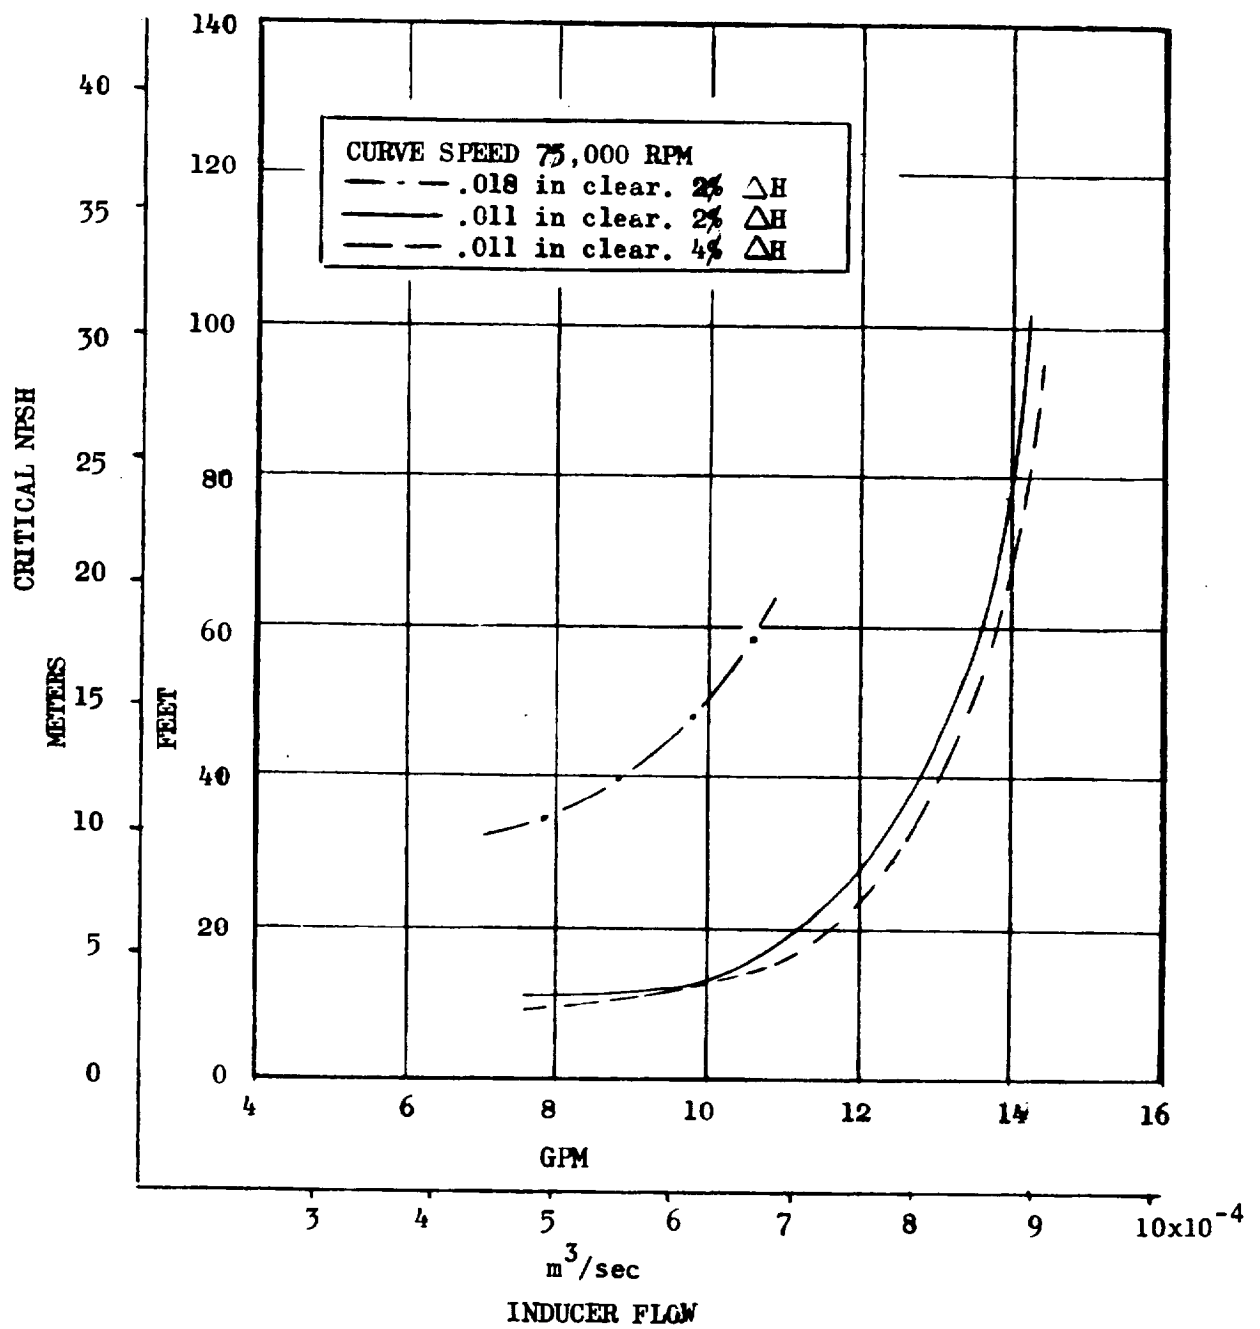
Figure 29. 12 gpm Rotating Pump Suction Performance in Freon 12

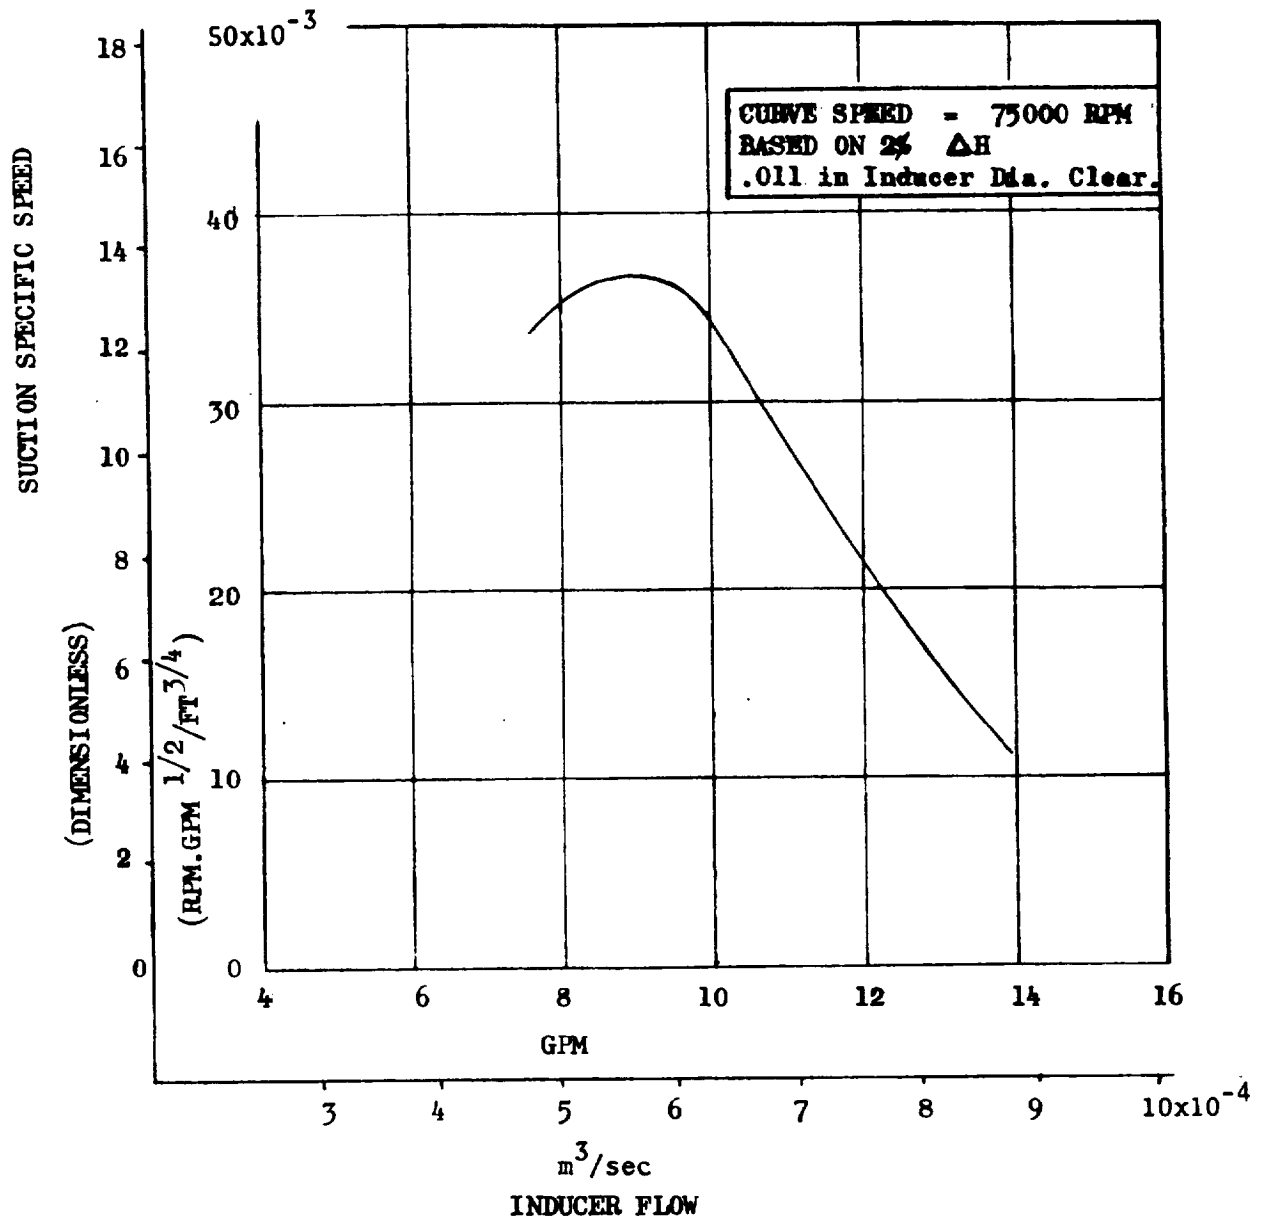
The above expression can be converted into dimensionless form by multiplying by the factor 3.66×10^{-4} (Ref. Eq. 1a, Volume I). The maximum suction specific speed attained was 36,500 (13.3 dimensionless) at 9 gpm ($5.68 \times 10^{-4} \text{ m}^3/\text{sec}$). At the design flow of 12 gpm ($7.56 \times 10^{-4} \text{ m}^3/\text{sec}$) the suction specific speed was 21,000 (7.7 dimensionless). The peak suction performance could be shifted to the design flow by increasing the inducer diameter.

Figure 30. 12 gpm Rotating Pump Suction Specific Speed in Freon 12

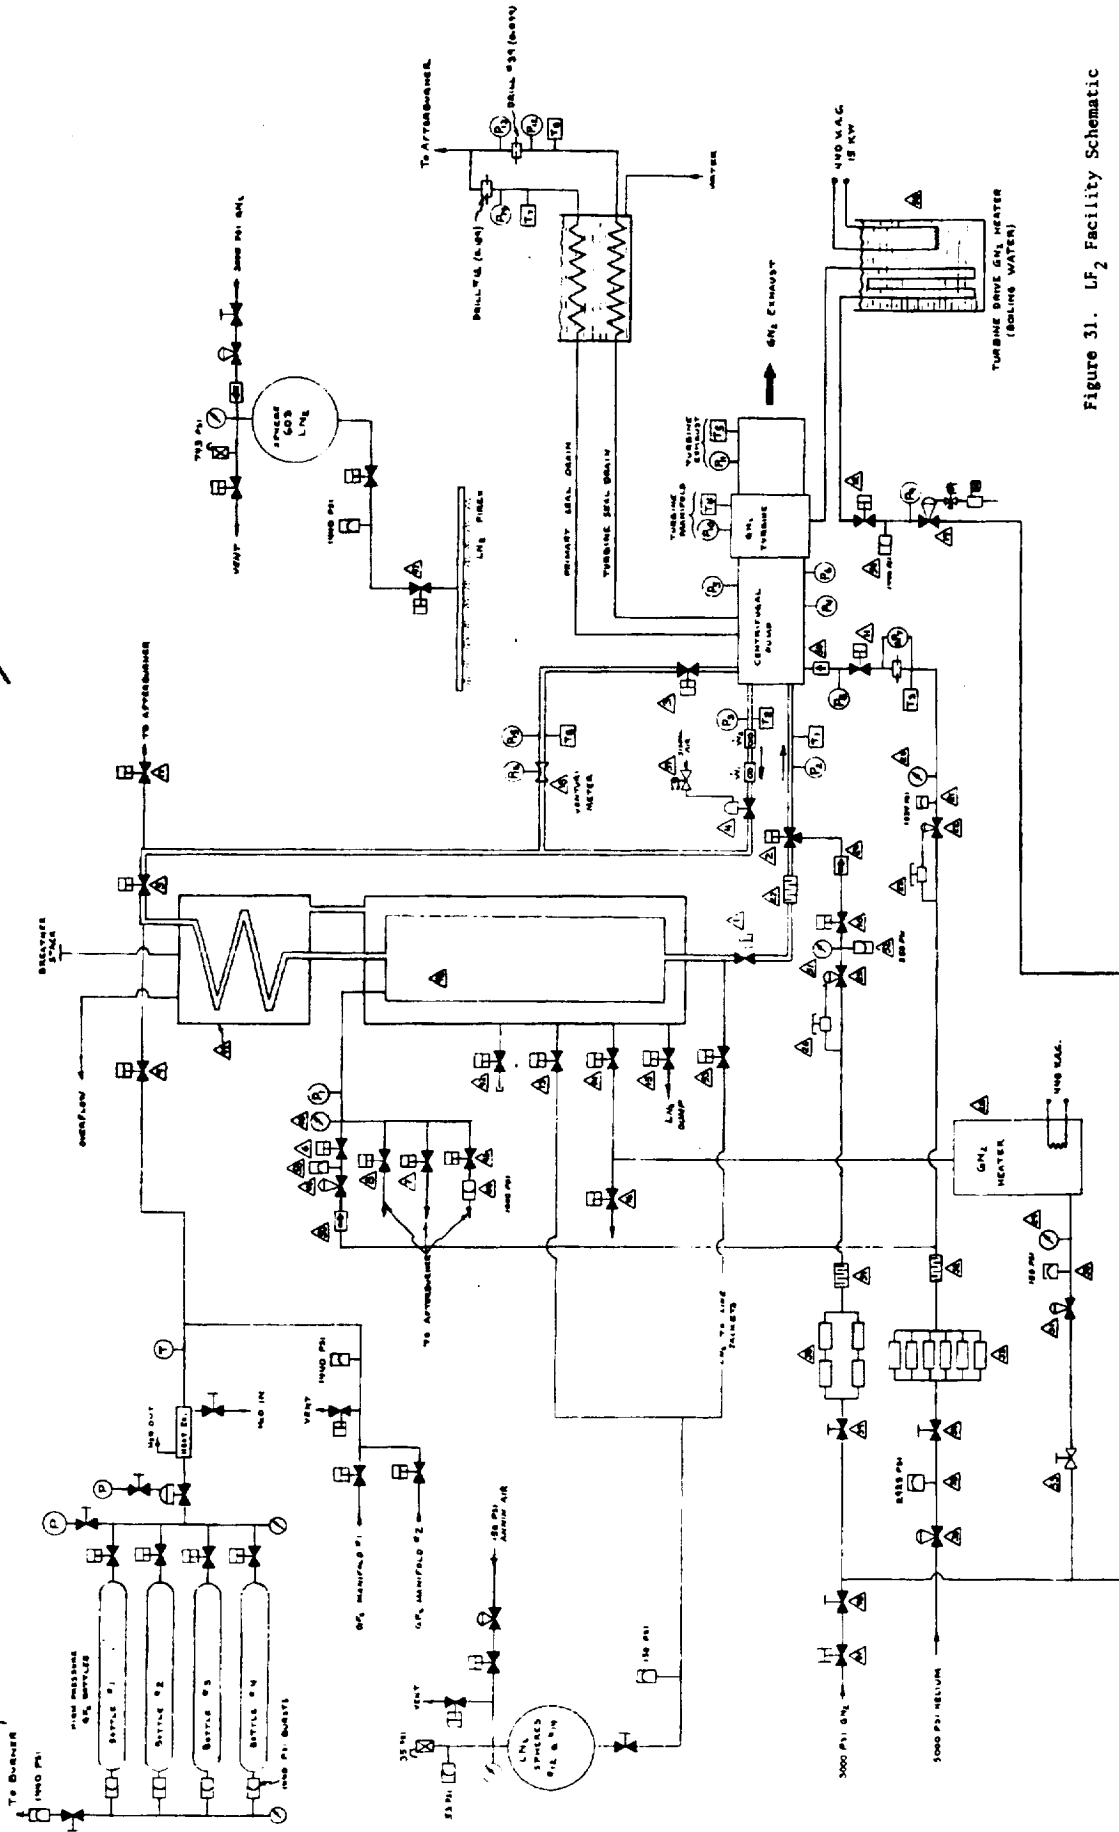
Figure 31. UF₂ Facility Schematic

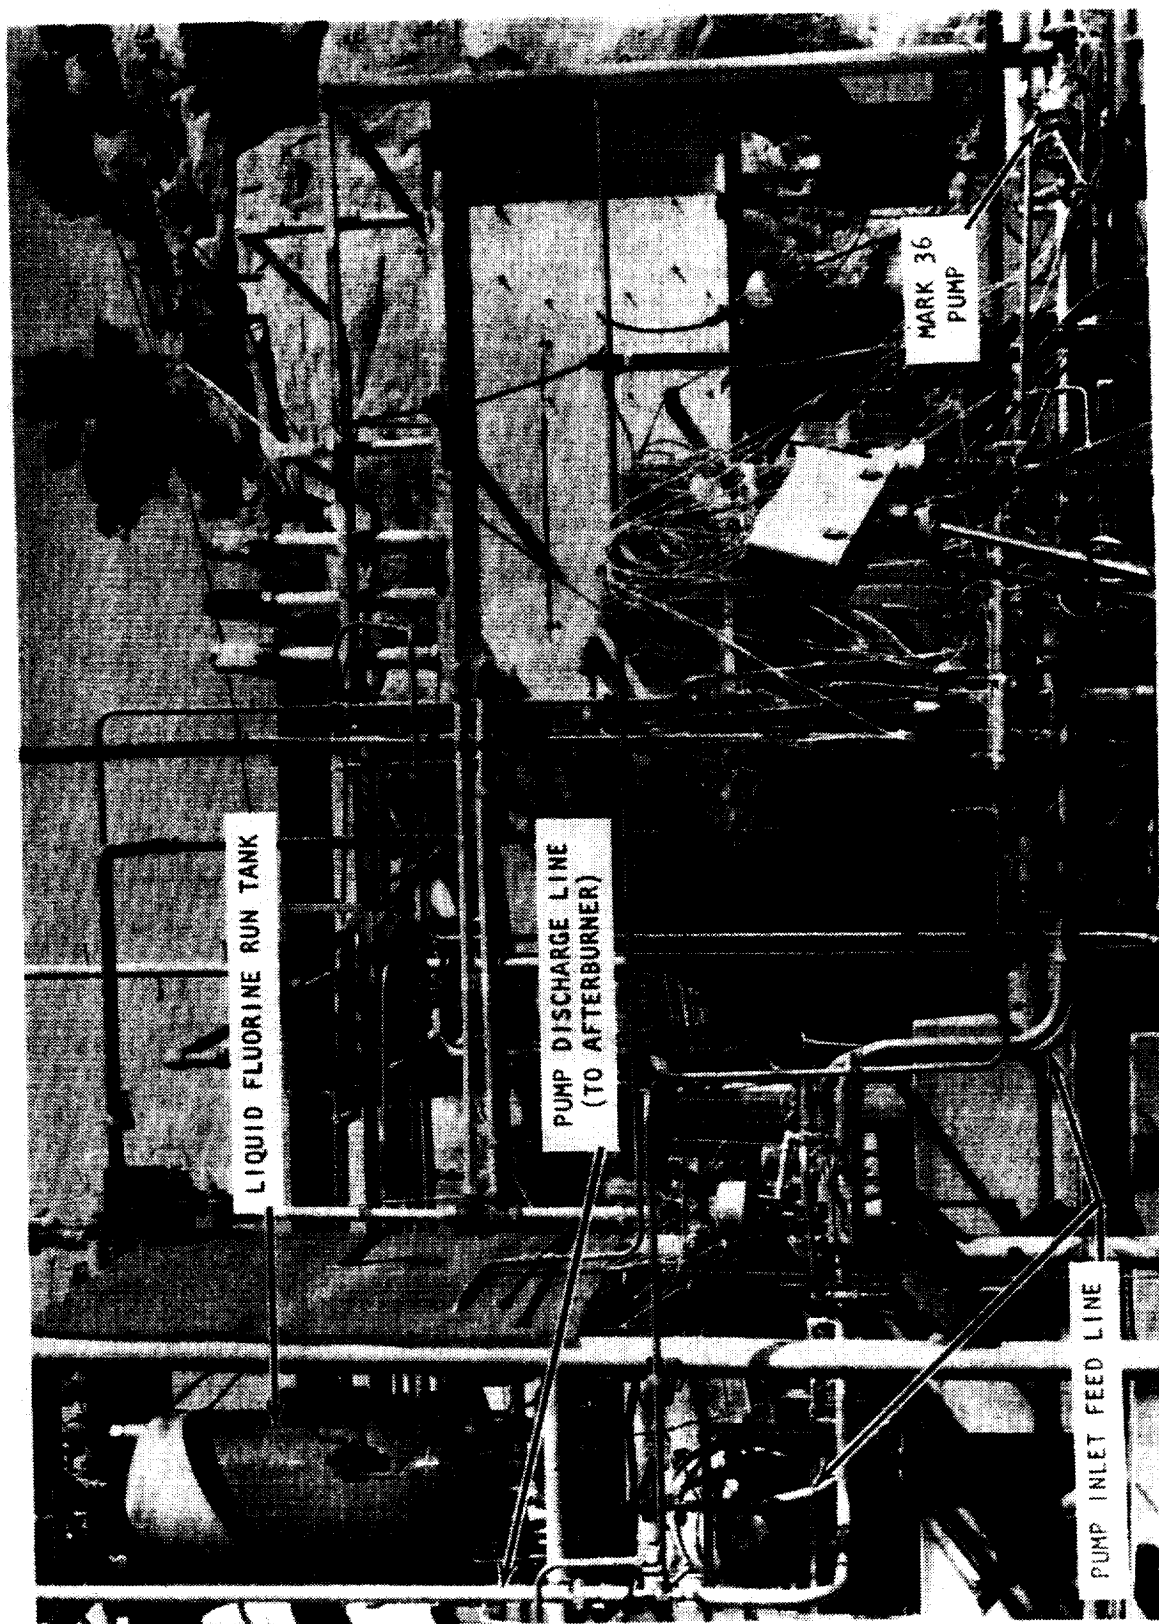
SAJ24-3/4/71-SIC

Figure 32. LF₂ Test Facility

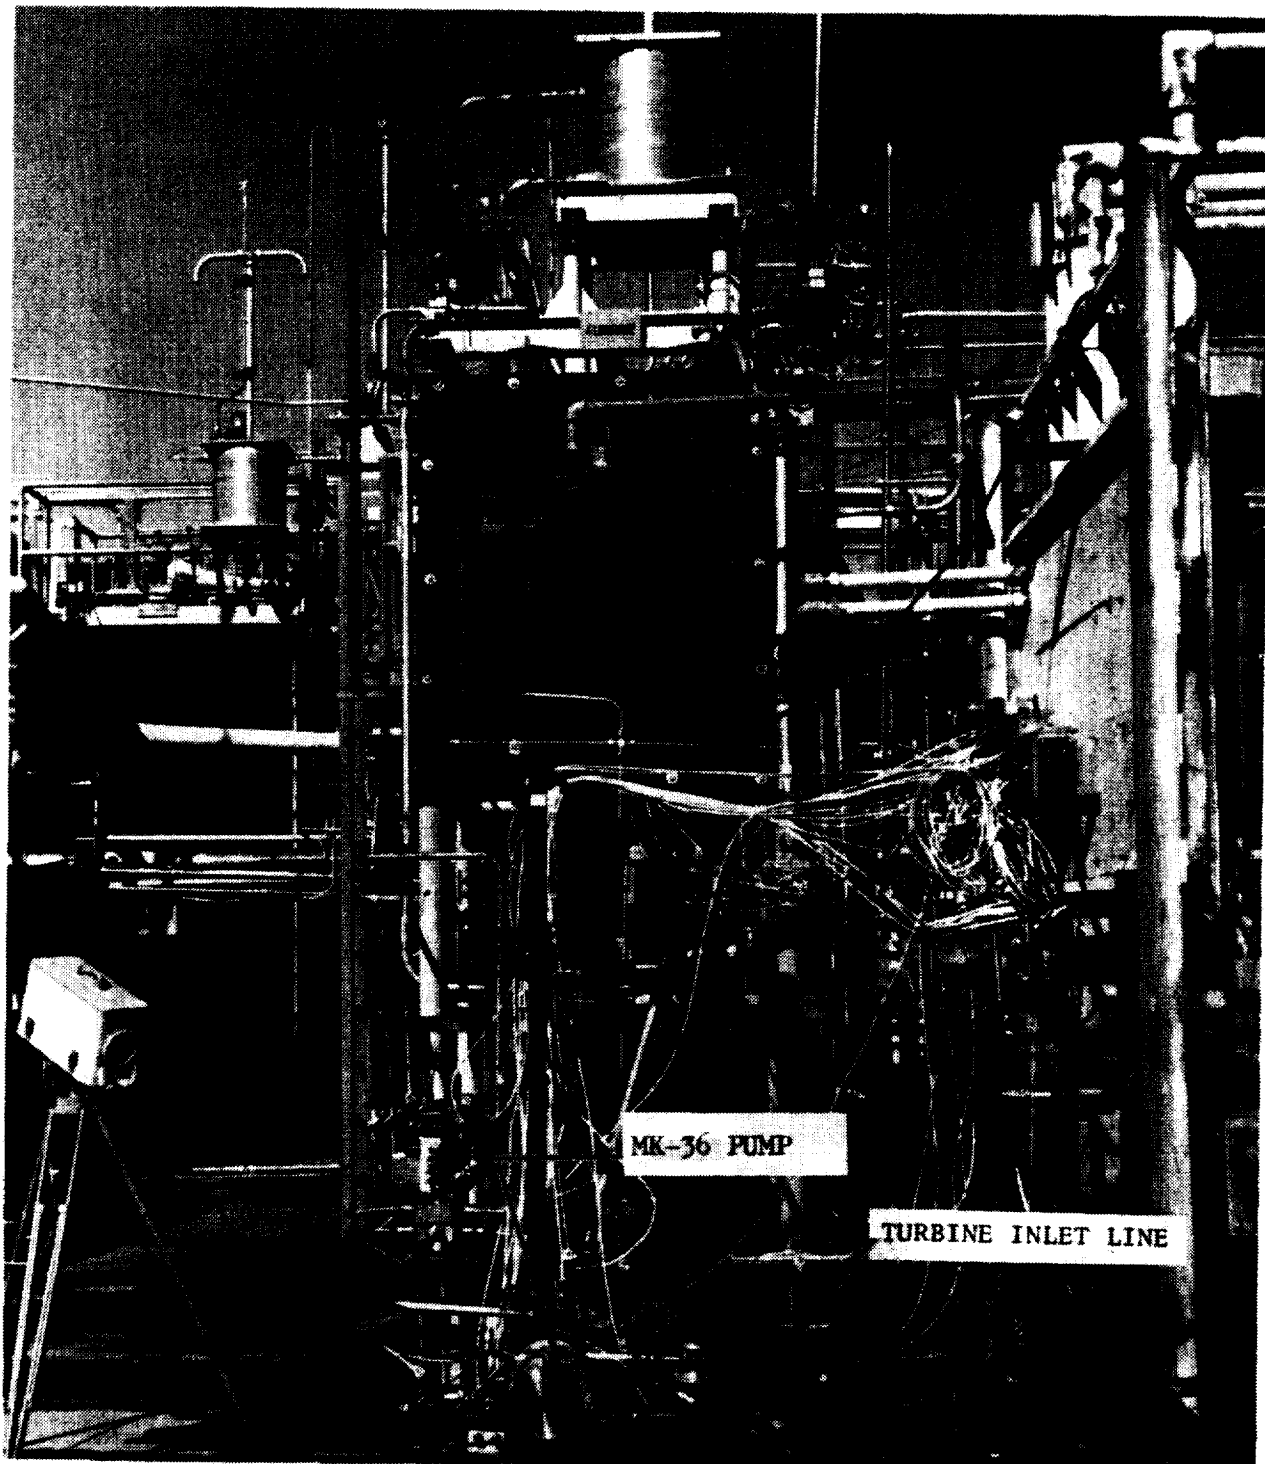
5AL24-3/4/71-S1F

Figure 33. LF_2 Test Facility

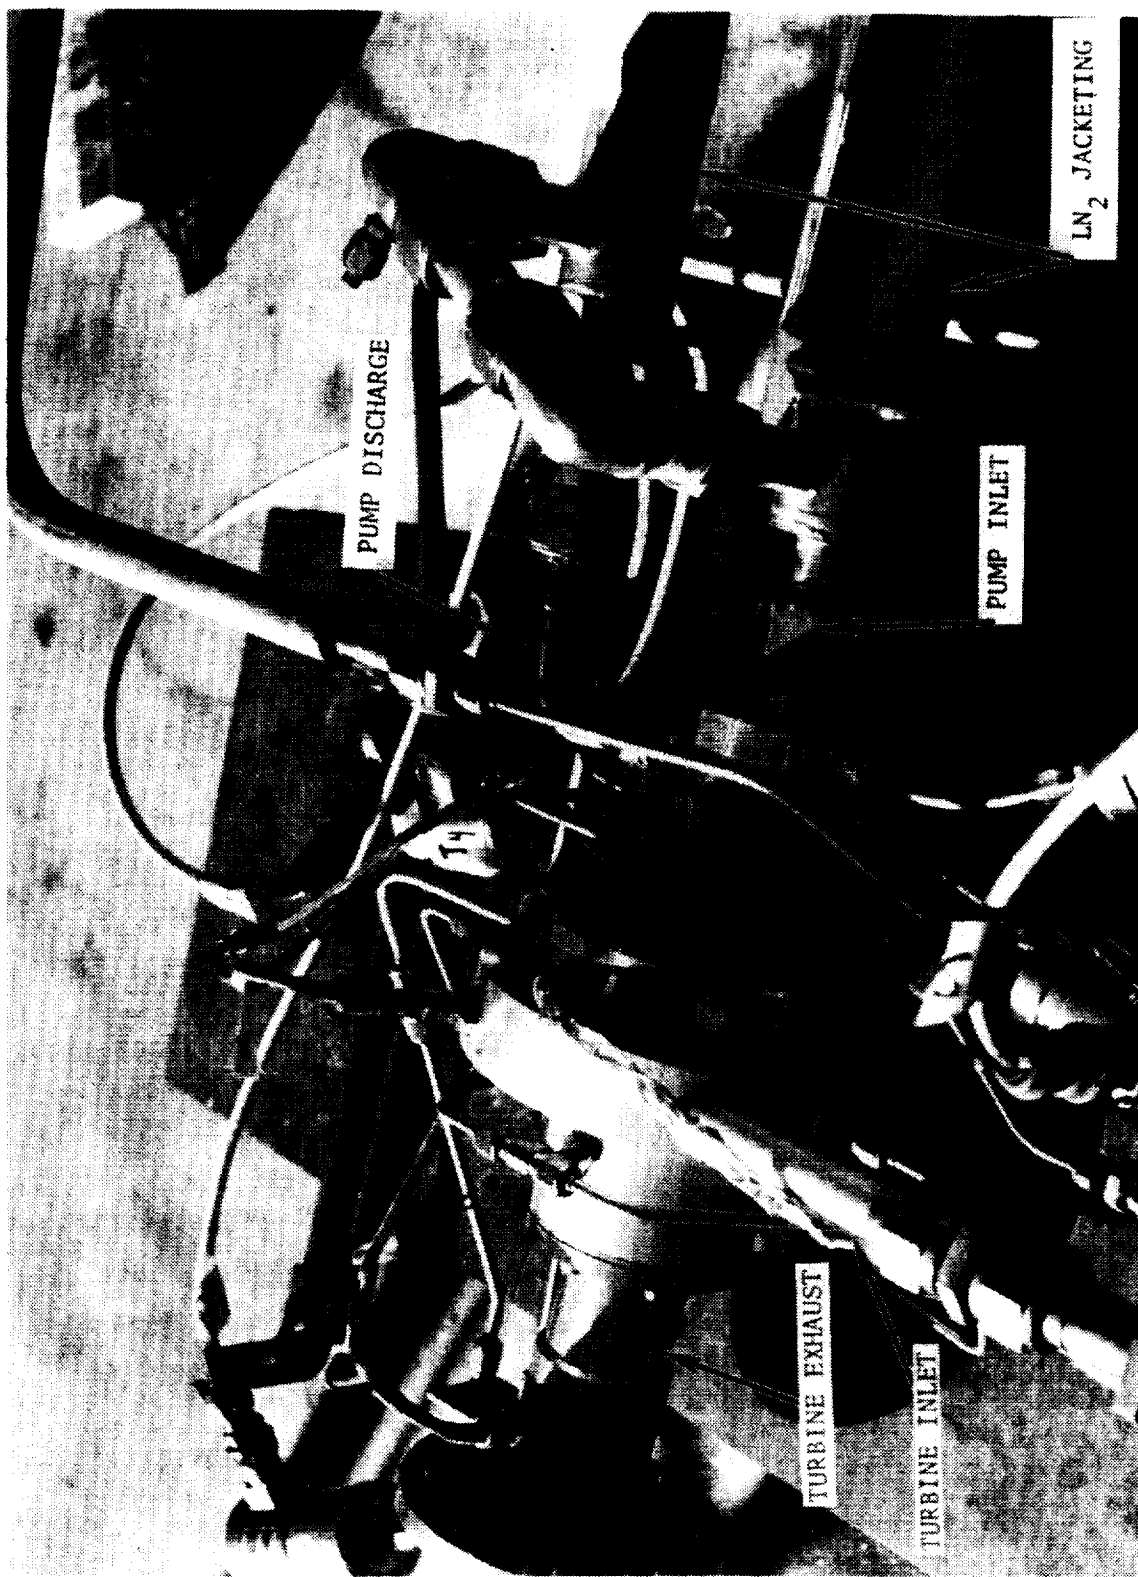
SAL24-3/4/71-S1D

Figure 34. Mark 36 Pump Installation in LF₂ Test Facility

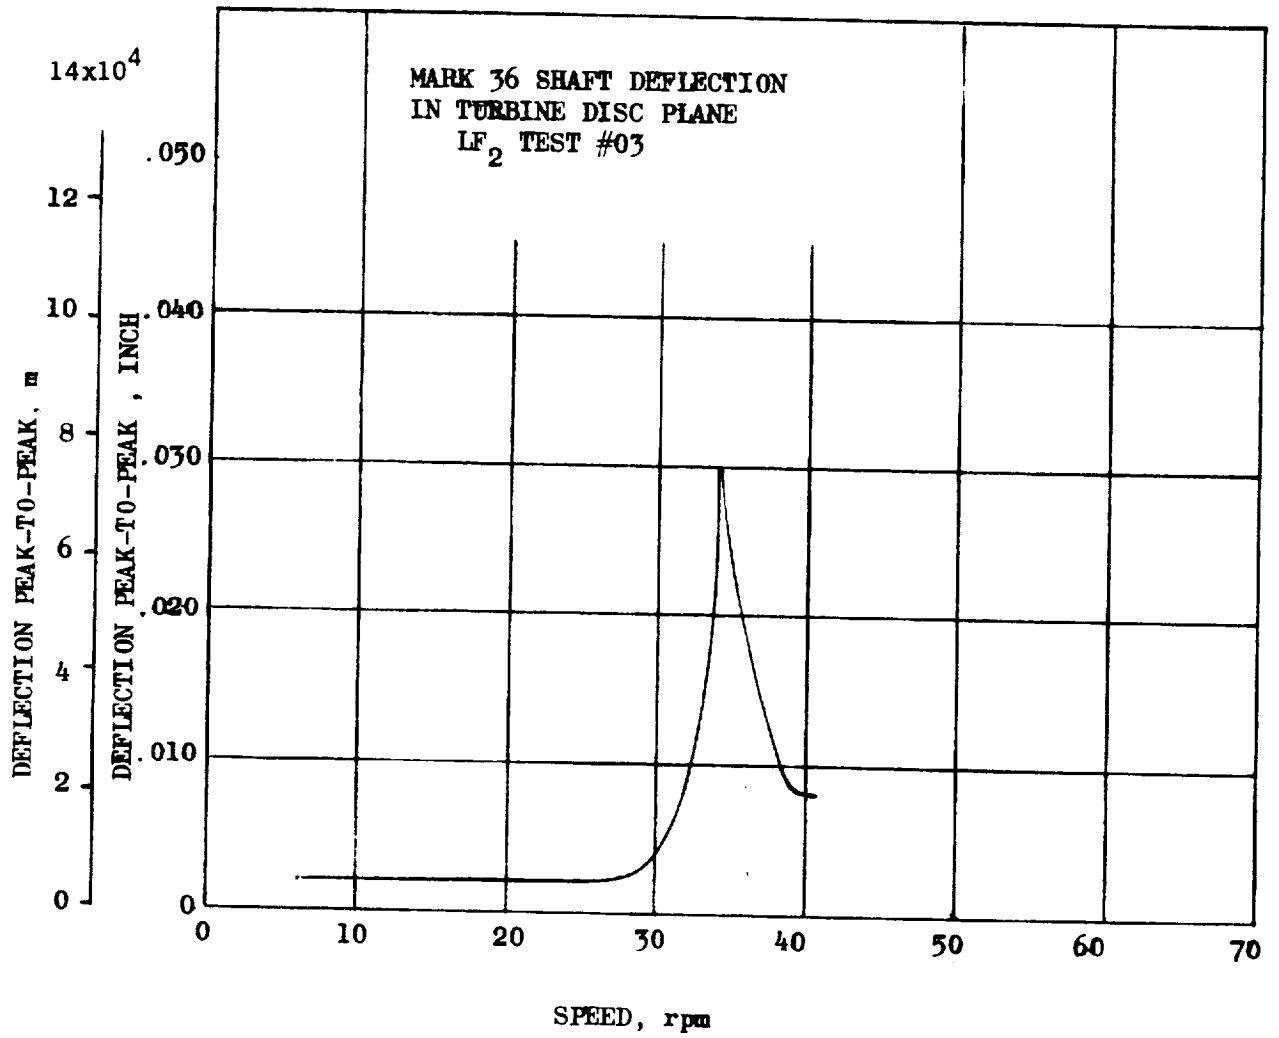
Approximately 15 seconds after Test #03 was terminated, during the procedure for securing the test stand, the turbine inlet valve was reopened by an operator error and the pump speed reached 92,000 rpm for approximately 3 seconds. Although the shaft vibration characteristics during the overspeed could not be evaluated because the high frequency tape was already turned off, shaft torque checks, seal leakage measurements, and dimensional checks after the test showed that the pump did not sustain any gross damage.

Figure 35. Mark 36 Shaft Deflection, LF₂ Test No. 03

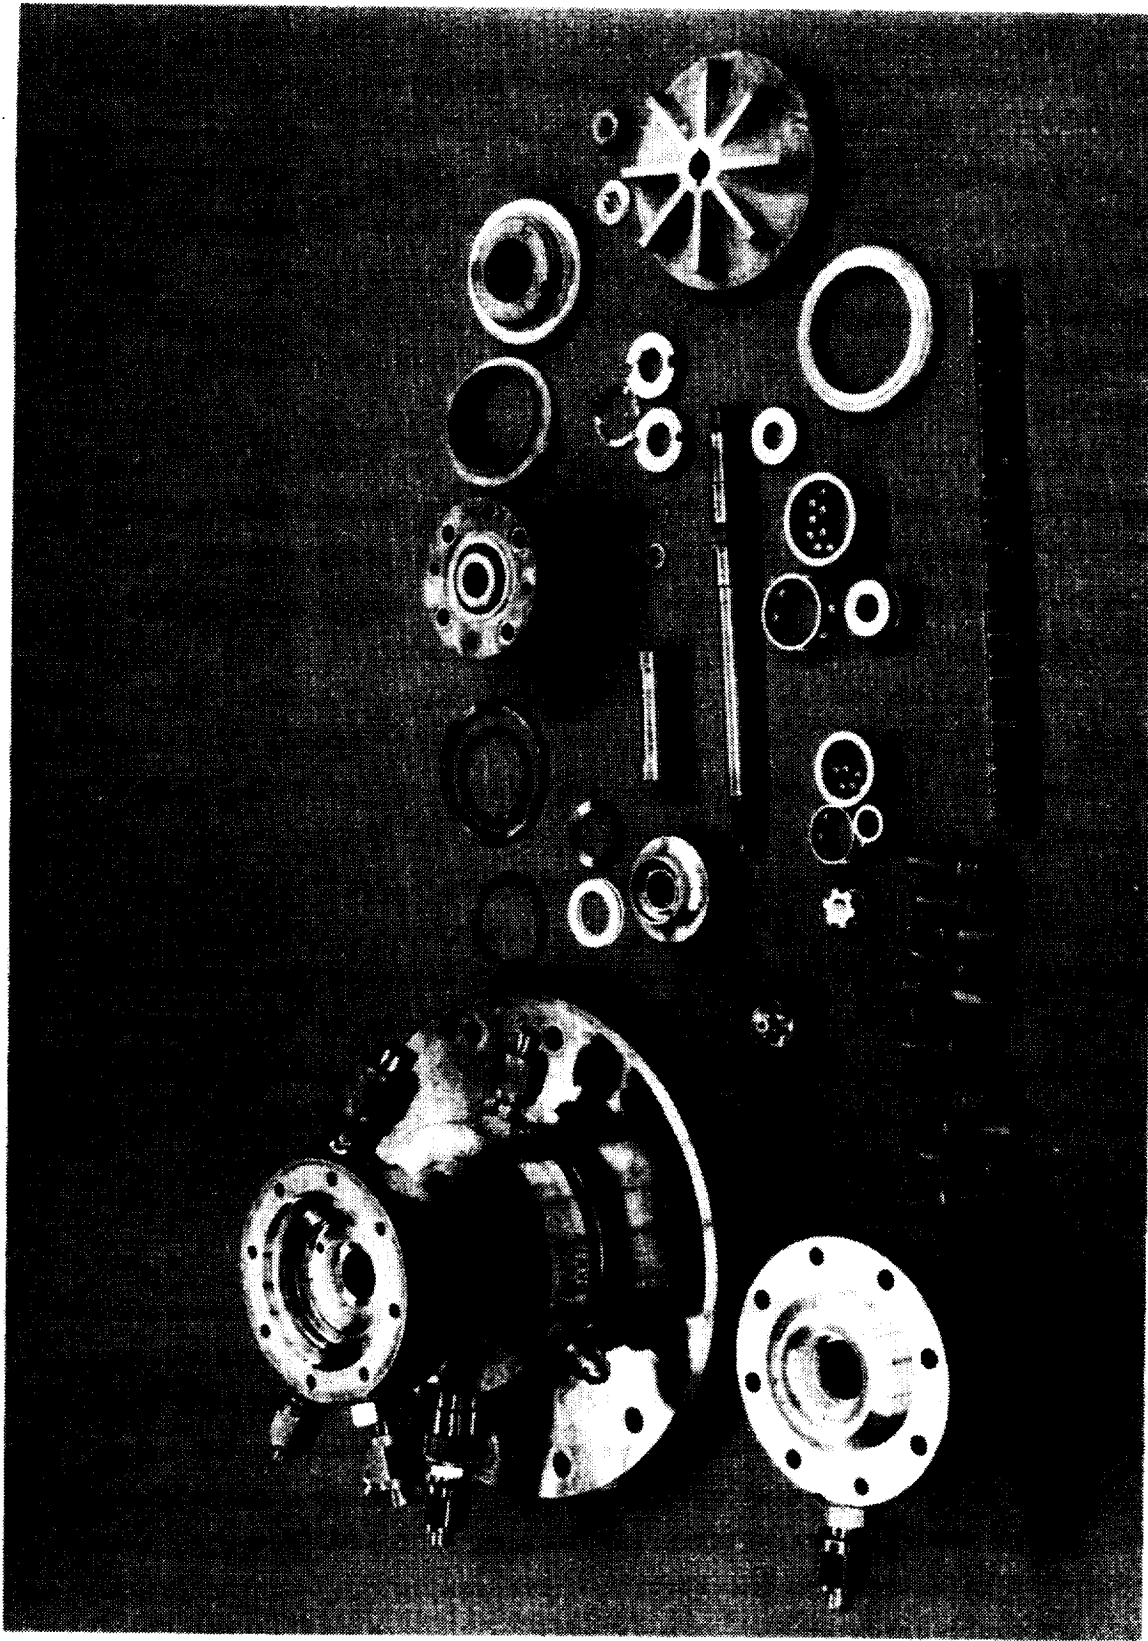
IXY55-4/5/71-CIH

Disassembly of the pump disclosed that the hardware was in general in good condition. No trace of fluorine burning was evident on components enclosed in the pump and exposed to liquid fluorine. The pump components after disassembly are shown in Figure 36.

Figure 36. Mark 36 Pump Components After LF_2 Testing

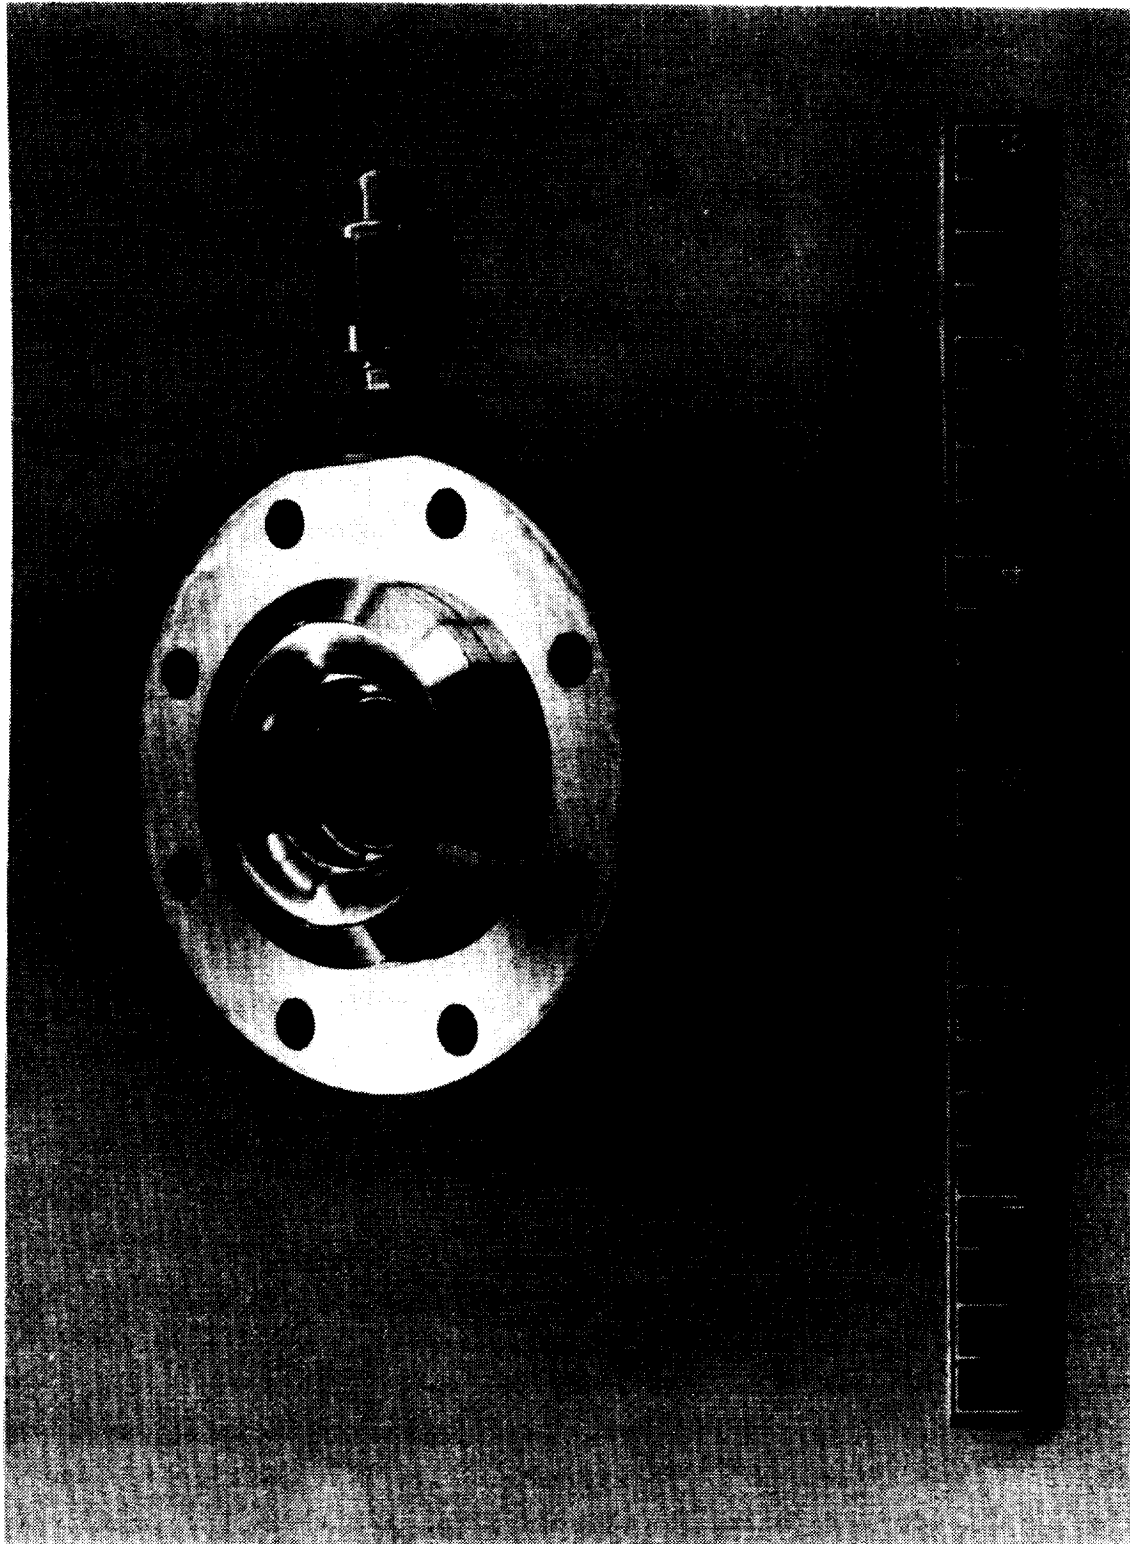
1XY55-4/5/71-CIF

Figure 37. Mark 36 Inlet Housing After LF_2 Tests

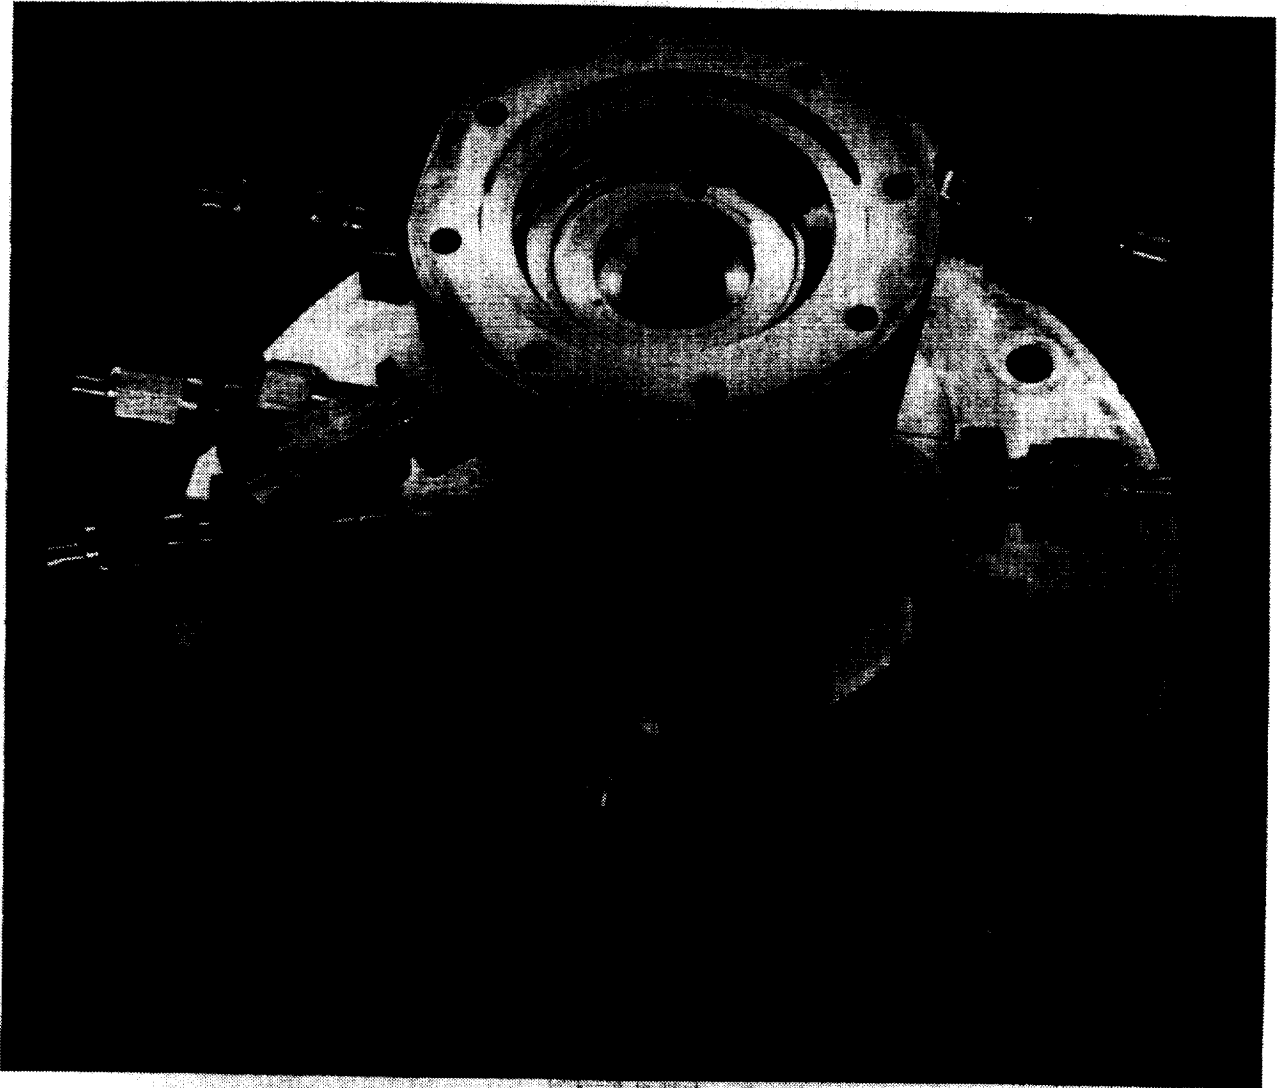
1XY55-4/5/71-C1G

Figure 38. Mark 36 Volute After LF₂ Testing

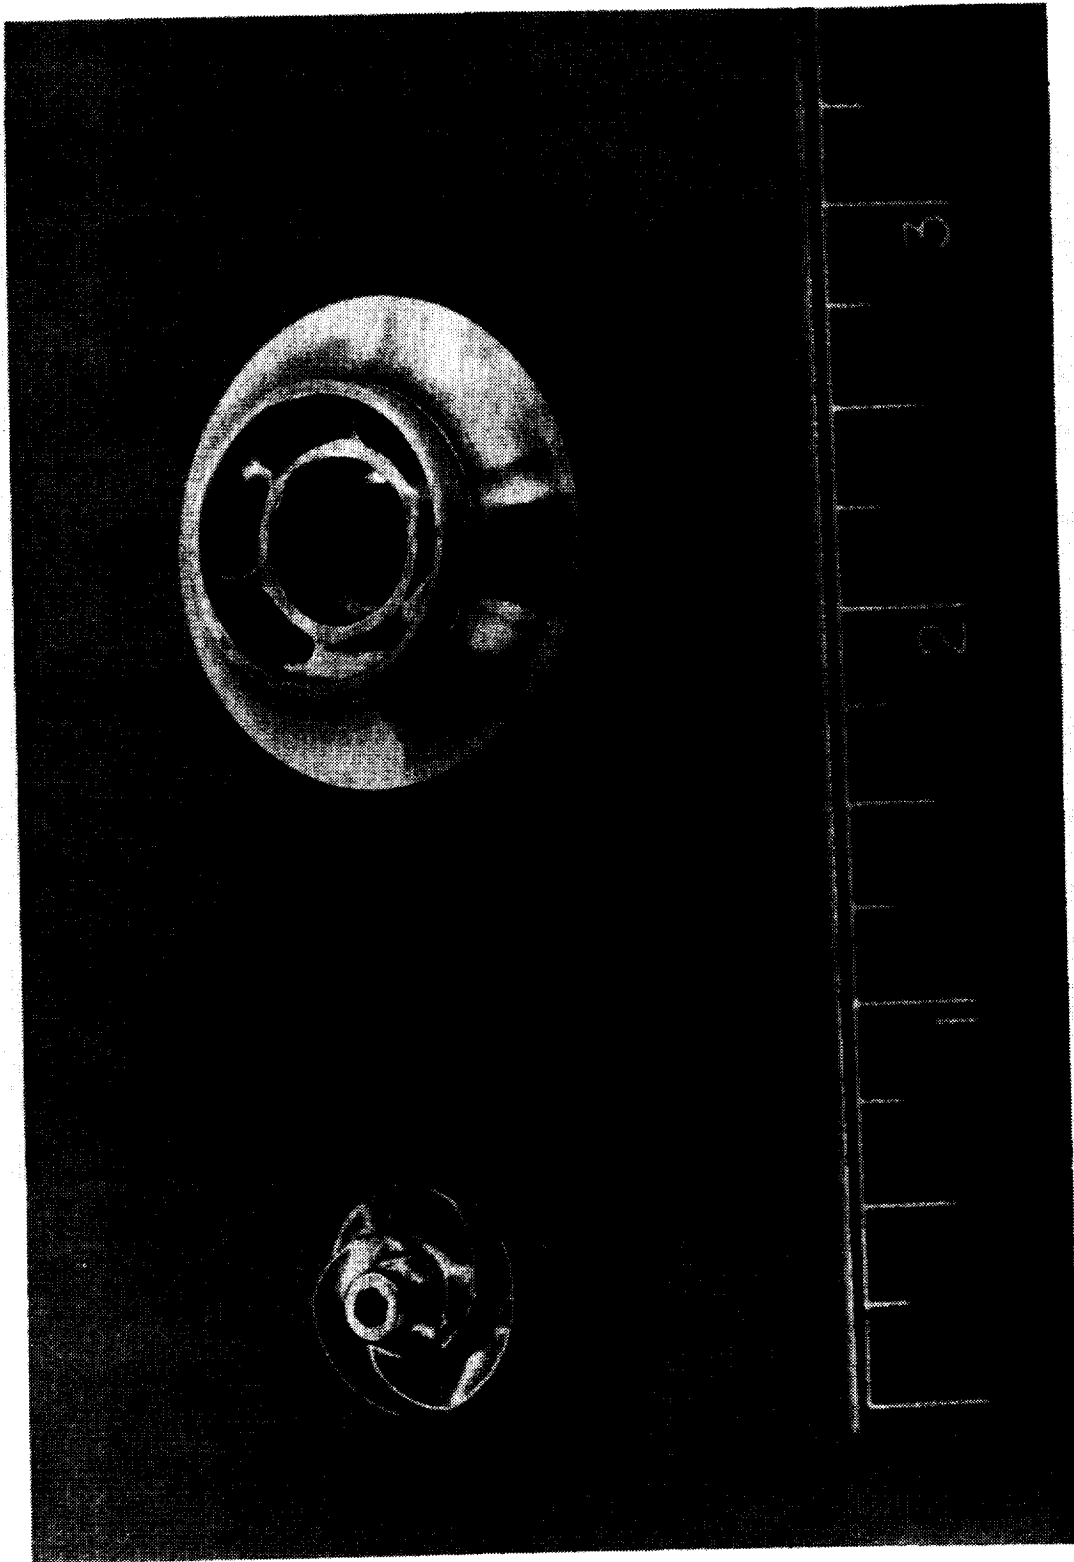
1XY55-4/S/71-C1E

Figure 39. Mark 36 Impeller and Inducer After LF₂ Testing
